Re: Clean Water Act Pretreatment Inspection

Enclosed is the report for our August 15, 2018 Pretreatment inspection of the Lost Coast Brewery facility at the above address in Eureka, CA.

**Region 9 Enforcement Division
75 Hawthorne Street
San Francisco, CA 94105
INSPECTION REPORT**

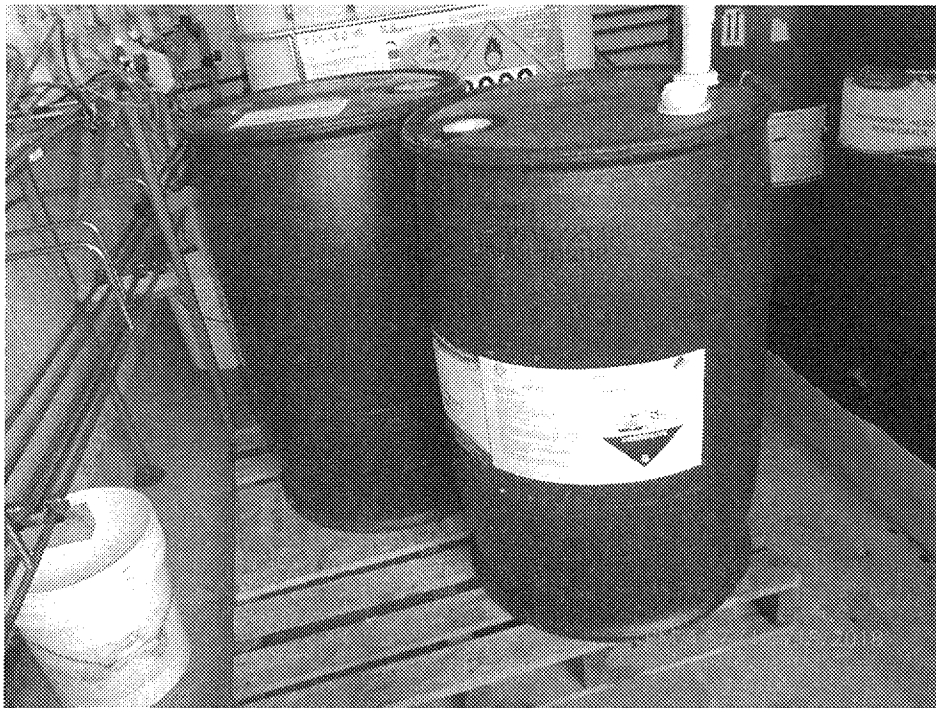
1. The facility was lacking secondary containment in the facility's main chemical storage area. Secondary containment was not observed for phosphoric acid and Stomp Sanitizer drums (Photograph 1 and 2). In addition, the surface of the secondary containment pallet underneath a peracetic acid and phosphoric acid drum was not intact and the phosphoric acid drum was not fully contained on the pallet (Photographs 3 and 4). It is recommended that the facility place chemicals drums in secondary containment to prevent discharge of chemicals to a floor drain or a storm drain.

Photograph 1. View of two phosphoric acid drums in the main chemical storage area. Note the lack of secondary containment.

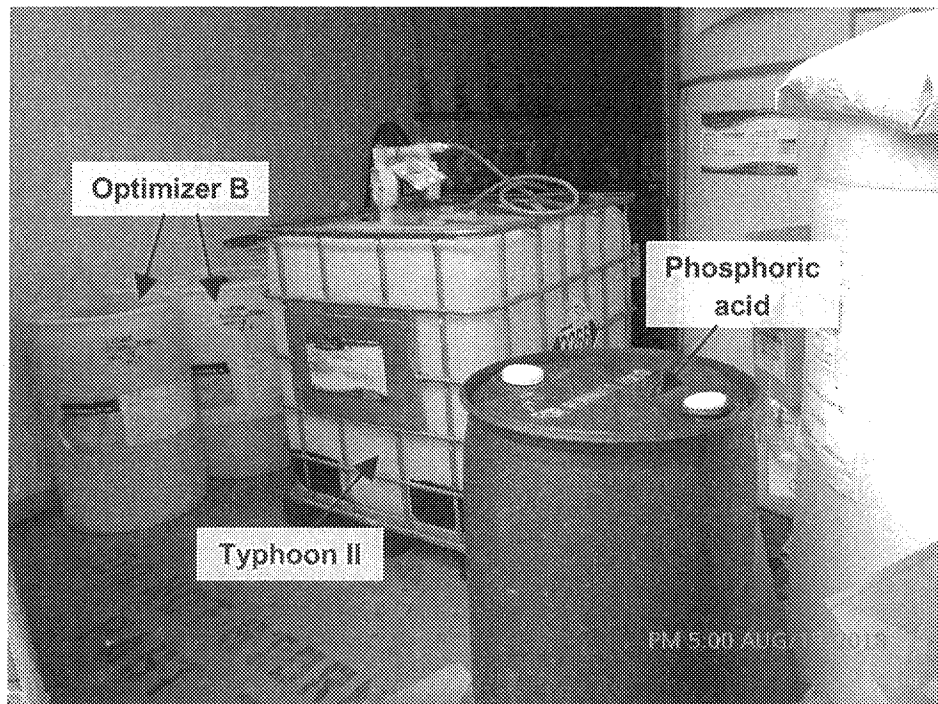
Photograph 2. View of the main chemical storage area. Note the lack of secondary containment for the IBC tote of Typhoon II (an alkaline cleaner), the drum of phosphoric acid, and the drums of Optimizer B.

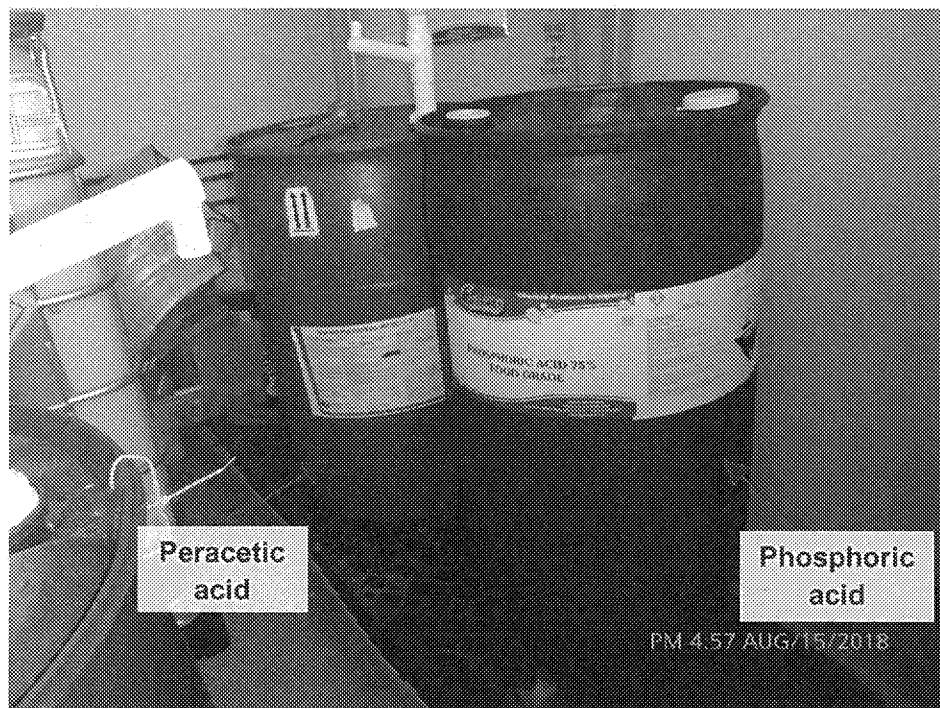
Photograph 3. View of a drum of phosphoric acid and a drum of peracetic acid.

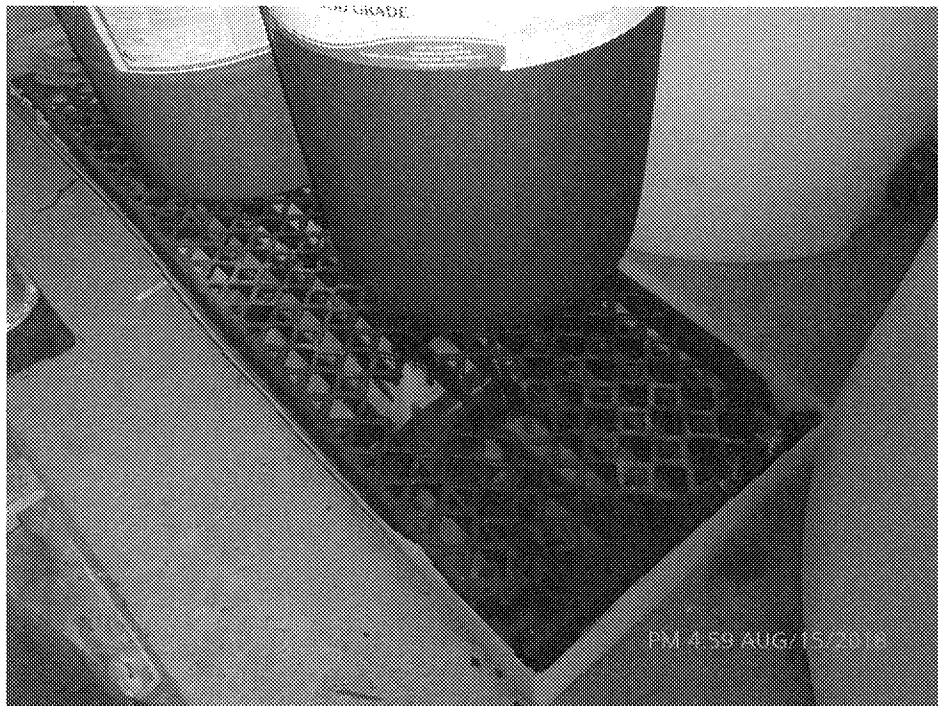
Photograph 4. View of the chemical drums and the secondary containment pallet shown in Photograph 3. Note the condition of the secondary containment pallet and that the nearest blue drum is not fully within secondary containment.

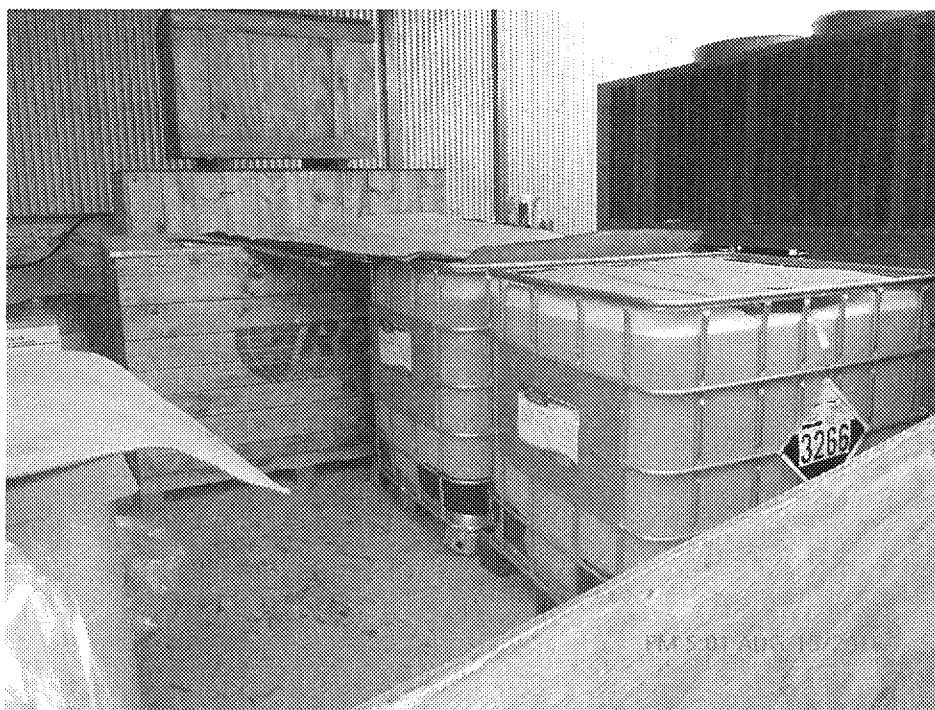
2. The facility was lacking secondary containment in chemical storage area #2. Secondary containment was not observed for IBC totes of sodium hydroxide and Typhoon II, drums of Optimizer B, drums of Cyclone, and drums of Chemeen 330 (Photographs 5-7). In addition, chemicals drums were observed without secondary containment nearby, adjacent to the facility's boiler system (Photograph 8). It is recommended that the facility place all chemical drums in secondary containment to prevent a discharge of chemicals to a floor drain or a storm drain.

Photograph 5. View of chemical storage area #2. Note the lack of secondary containment for the IBC totes of sodium hydroxide and Typhoon II (an alkaline cleanser).

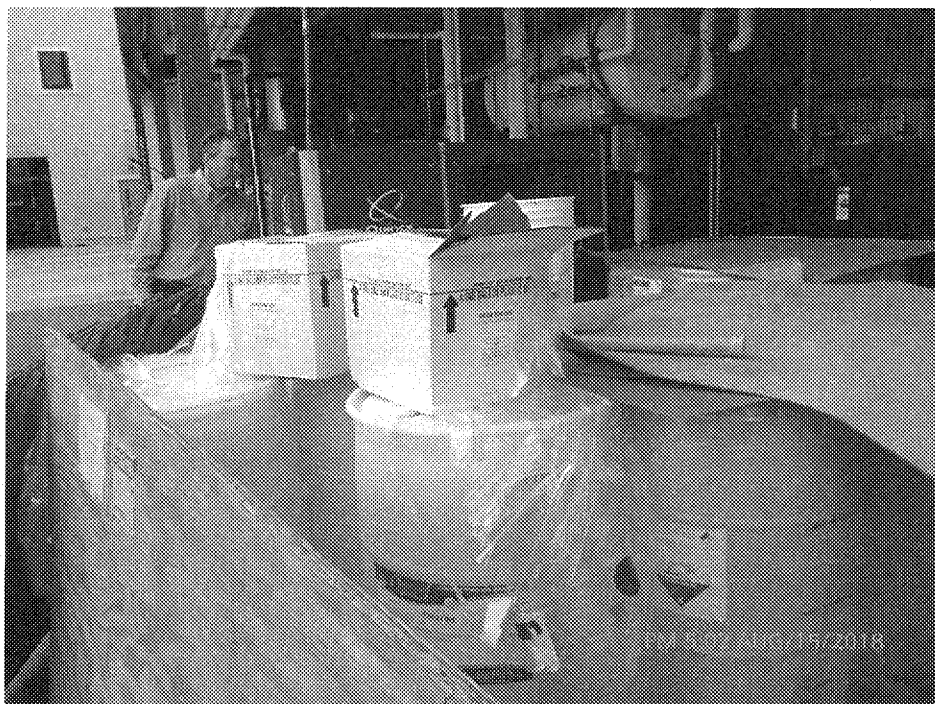
Photograph 6. View of chemical storage area #2 shown in Photographs 5 and 7. This photo shows the area referenced in Item 2 in the *Areas of Concern* section of this report.

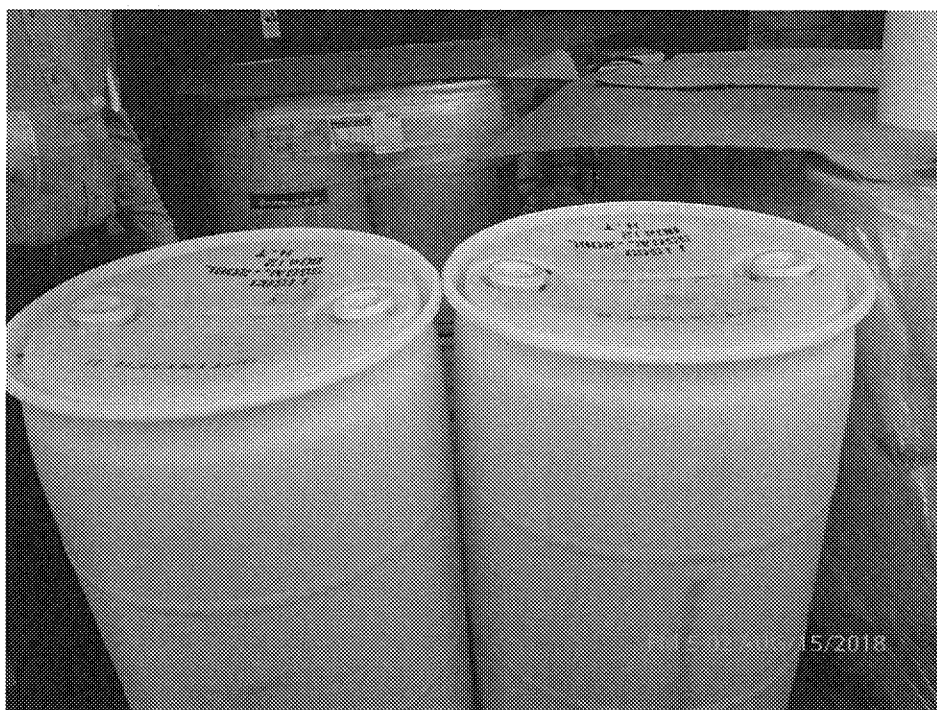
Photograph 7. View of chemical storage area #2 shown in Photographs 5 and 6. This photo shows the area referenced in Item 2 in the *Areas of Concern* section of this report.

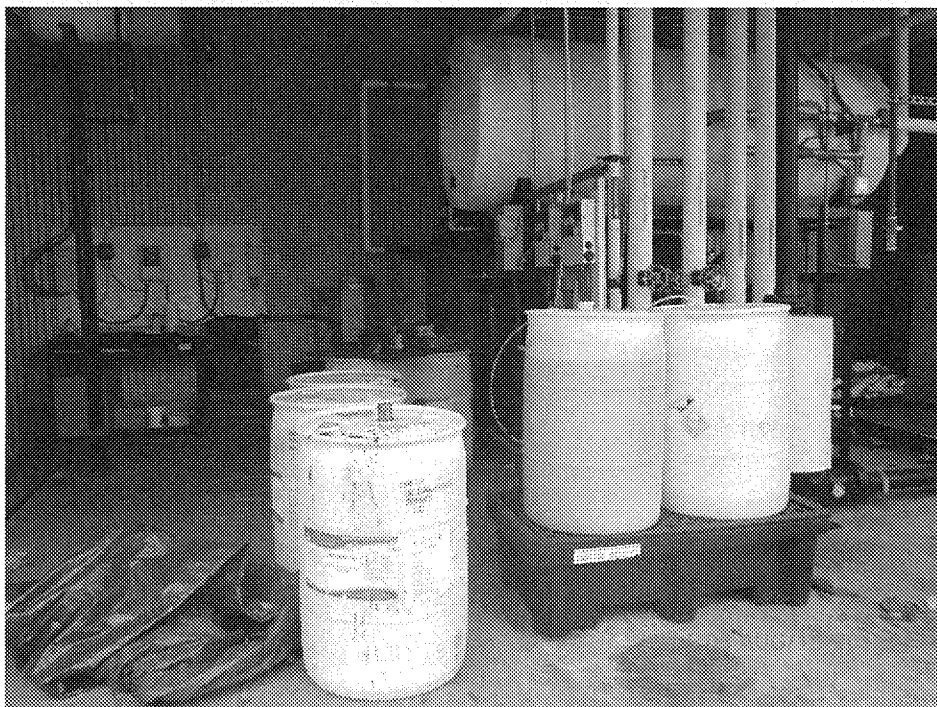
Photograph 8. View of the chemical storage drums stored near the facility's boiler. Note the lack of secondary containment.

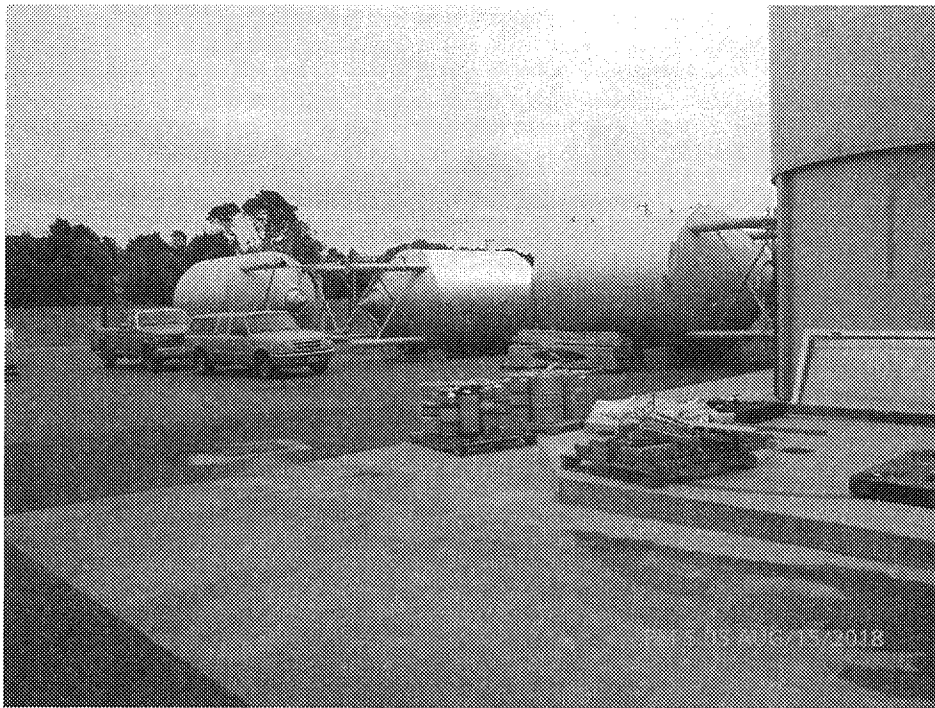
3. The inspection team observed three uninstalled fermentation tanks (Photograph 9) near chemical storage area #2. According to the facility representative, the facility plans to install the fermentation tanks in the future, though a time had not yet been established. The federal regulations at 40 CFR 403.12(j) require SIUs to "...notify the Control Authority ... in advance of any substantial change in the volume or character of pollutants in their Discharge..." Therefore, the facility is required to notify the City prior to installation of these fermentation tanks and any subsequent changes to its process wastewater discharge.

Photograph 9. View of three fermentation tanks that the facility plans to install in the future.

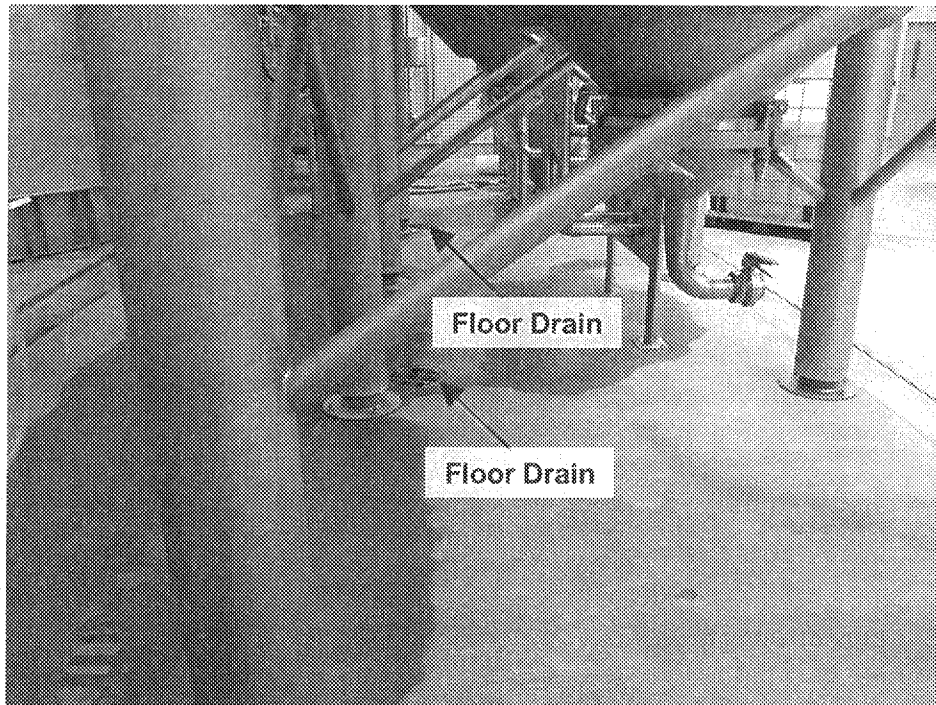
4. Water was observed near the outdoor fermentation tanks. According to the facility representative, an employee washed down the area around one of the fermentation tanks where the facility is producing cider. The water was observed around drains located directly under the fermentation tanks (Photographs 10 and 11). According to the facility representative, these drains direct flow to the pretreatment system. Due to the location of these drains it appears that they may capture stormwater. Part 3.B.11 of the facility's discharge permit prohibits the discharge of, "[s]tormwater, surface water, ground water, artisan well water, roof runoff, subsurface drainage, swimming pool drainage,

condensate, deionized water, noncontact cooling water, and unpolluted industrial wastewater, unless specifically authorized in writing by the City Manager.” The facility is required to ensure that it does not discharge stormwater to the City’s sanitary sewer.

Photograph 10. View of fermentation tanks located outside the facility's indoor brewing area. Water was observed on the ground underneath the tanks. The drains direct wastewater to the facility's pretreatment system.

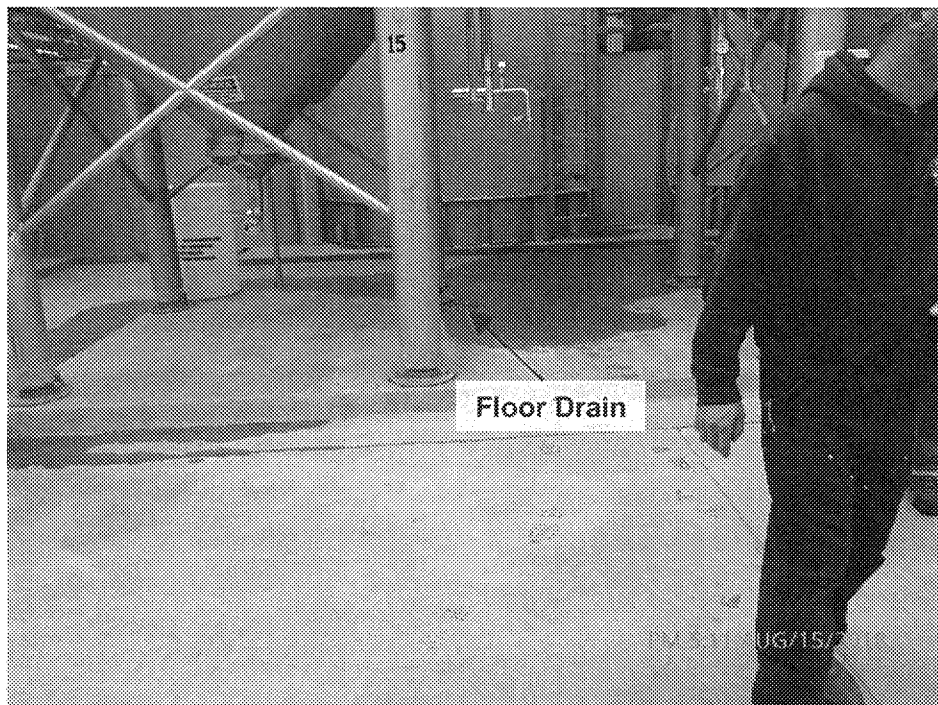
Photograph 11. Another view of the outdoor fermentation tanks and drains that direct flow to the facility's pretreatment system.

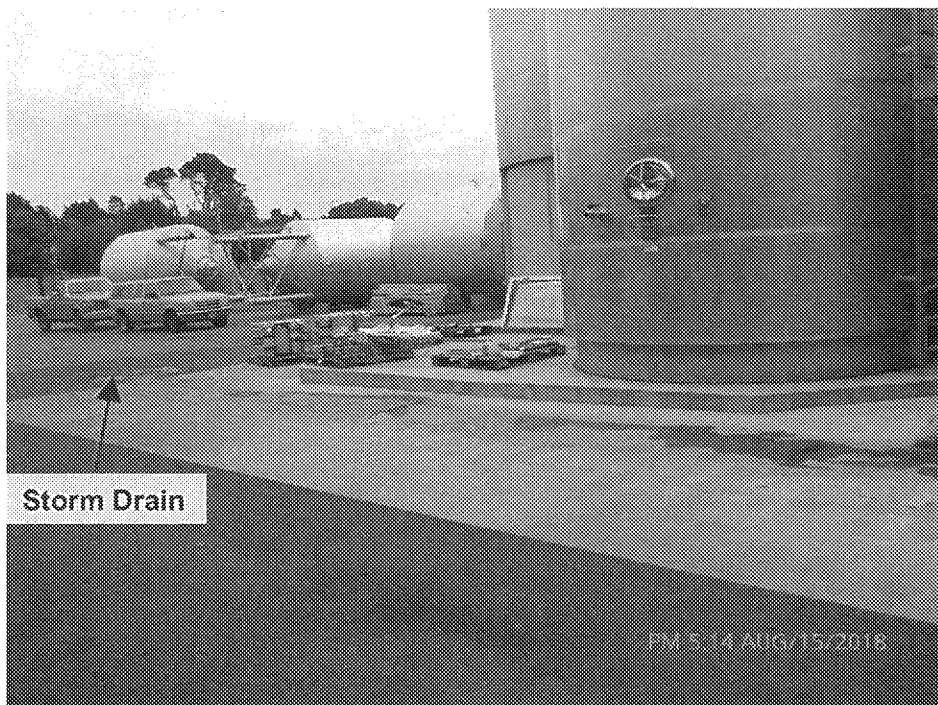
Furthermore, this water was also observed flowing into a nearby storm drain (Photograph 12). Subsection 54.040.A of the City of Eureka’s Stormwater Ordinance (Ordinance No. 705 -C.S) states “No person shall discharge or cause to be discharged into the storm drainage facilities or watercourses any materials, including but not limited to pollutants or waters containing any pollutants that cause or contribute to a violation of applicable water quality standards, other than storm water.” The facility is required to prevent wastewater from flowing to storm drains.

Photograph 12. View of the water shown in Photographs 10 and 11 flowing into a storm drain.

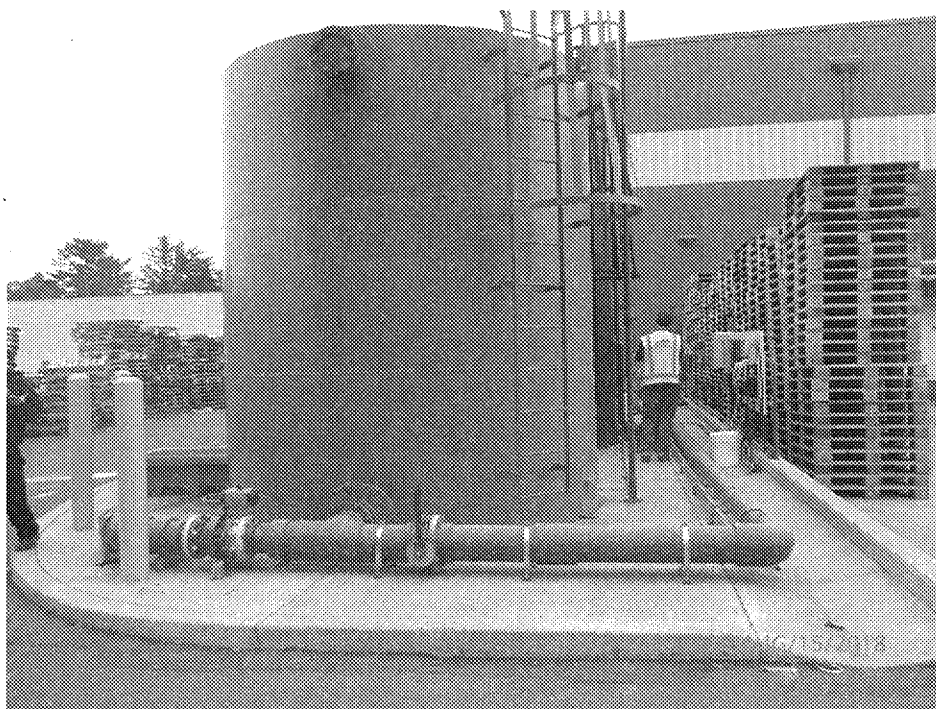
6. The facility’s pretreatment consists of three metal tanks outside the northeast side of the building. However, the inspection team observed that there is no secondary containment surrounding the tanks (Photographs 13 and 14). Furthermore, an IBC tote of sodium hydroxide was observed between Tanks 2 and 3 and a white stain in the facility driveway suggested a previous spill of sodium hydroxide (Photographs 14 and 15). It is recommended that the facility install secondary containment around the three pretreatment tanks and the sodium hydroxide tote.

Photograph 13. View of Tank 3 of the facility's pretreatment system. Note the lack of secondary containment around the pretreatment tanks.

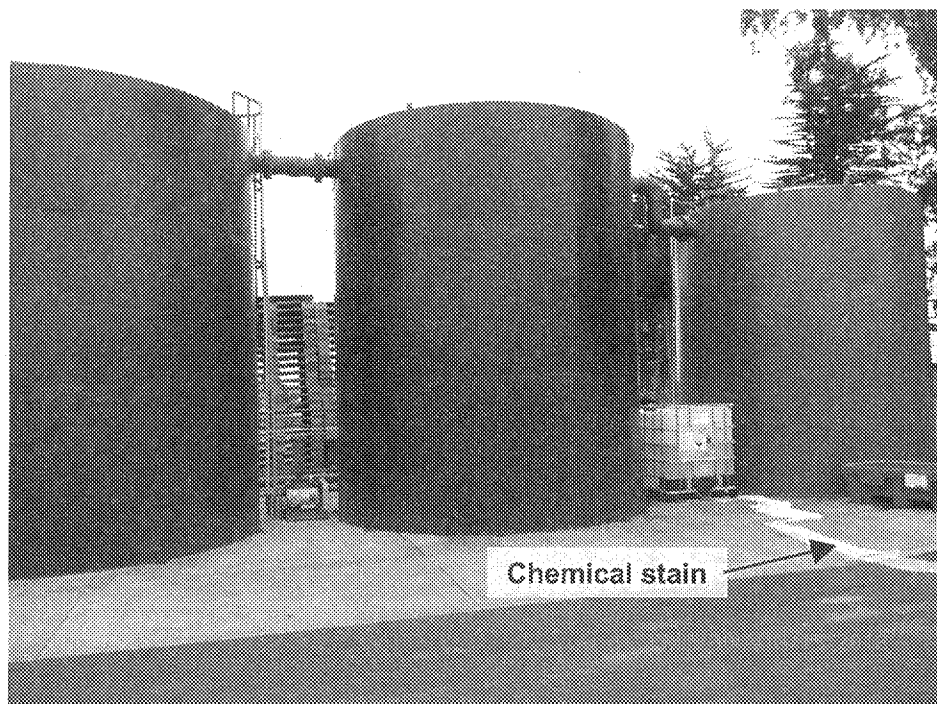
Photograph 14. View of the facility's three pretreatment tanks. Note the lack of secondary containment around the tanks and the white stain of sodium hydroxide from a spill from the IBC tote shown in Photograph 15.

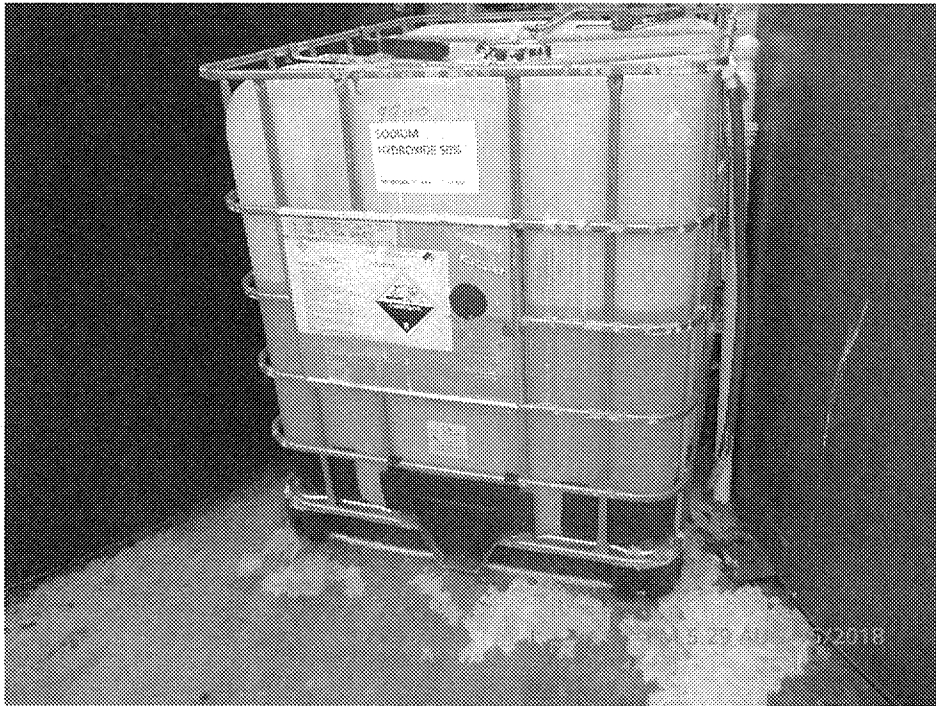
Photograph 15. View of an IBC tote of sodium hydroxide, located between tanks 2 and 3 of the facility's pretreatment system.

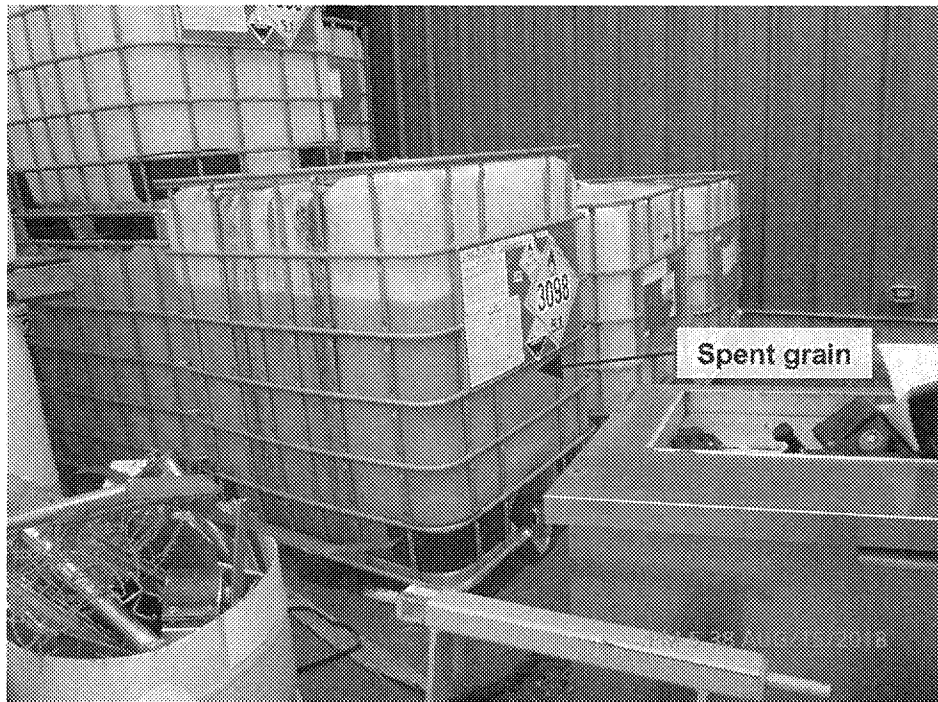
7. Along the east side of the building the facility had a collection of empty drums and totes. One IBC tote was labeled “Stomp Sanitizer” (Photograph 16); however, according to the facility representative, the tote contained spent yeast that was ready to be hauled offsite. It is recommended that the facility relabel the tote to accurately identify the contents of the tote.

Photograph 16. View of an IBC tote labeled as "Stomp Sanitizer". According to the facility representative, the tote contains spent yeast.
